**MEMORANDUM REPORT VRTC-DCD-6102
EA05-022**

Investigation of Front Seatbelt Buckle Malfunction in 2002 Jeep Liberty Vehicles

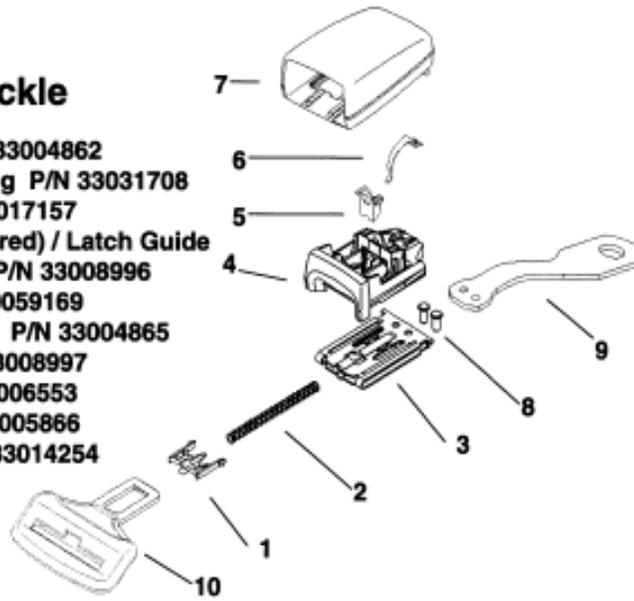
RNS-3G Buckle

1. Ejector P/N 33004862
2. Ejector Spring P/N 33031708
3. Base P/N 33017157
4. Pushbutton (red) / Latch Guide (magenta) P/N 33008996
5. Latch P/N 00059169
6. Latch Spring P/N 33004865
7. Cover P/N 33008997
8. Rivet P/N 33006553
9. Strap P/N 33005866
10. Tongue P/N 33014254
